5.4 DETECTION OF CRACKS IN TRIGA FUEL RODS BY NEUTRON RADIOGRAPHY, W. A. Pochman, A. Zeilinger, H. Böck, (Atominstitut, Vienna, Austria)

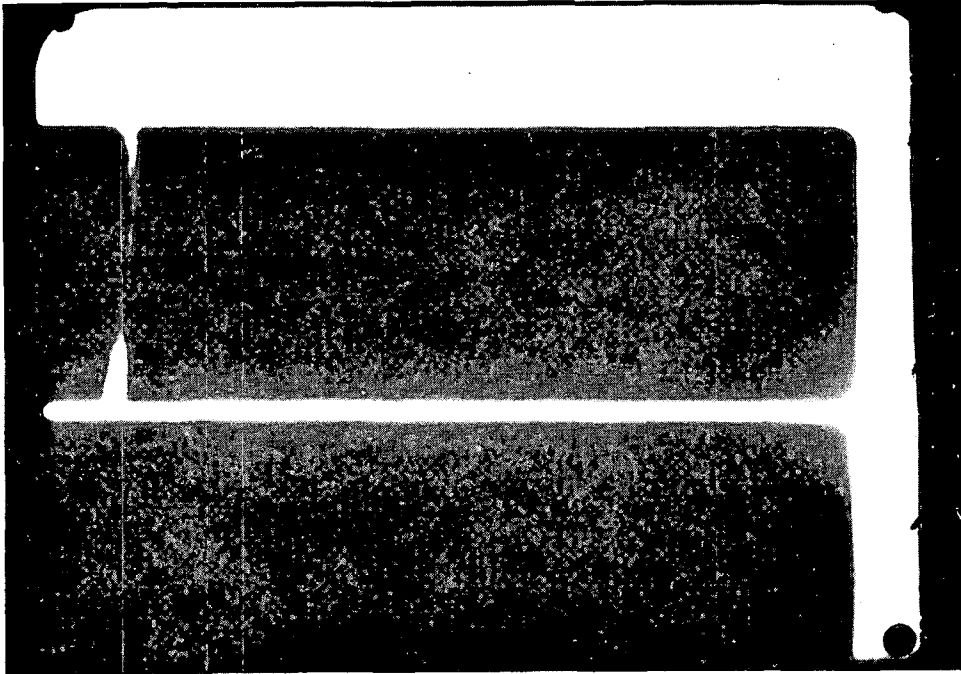
Fig.2

The first radiograph, obtained in the way just described, shows a crack in the enriched U-ZrH alloy of the upper fuel rod (No. 7307). The crack, clearly be seen on the radiographs (Fig.2, Fig.3), having a distance of about 9 cm from the end of the lower graphite briquette, seems to run totally through the fuel

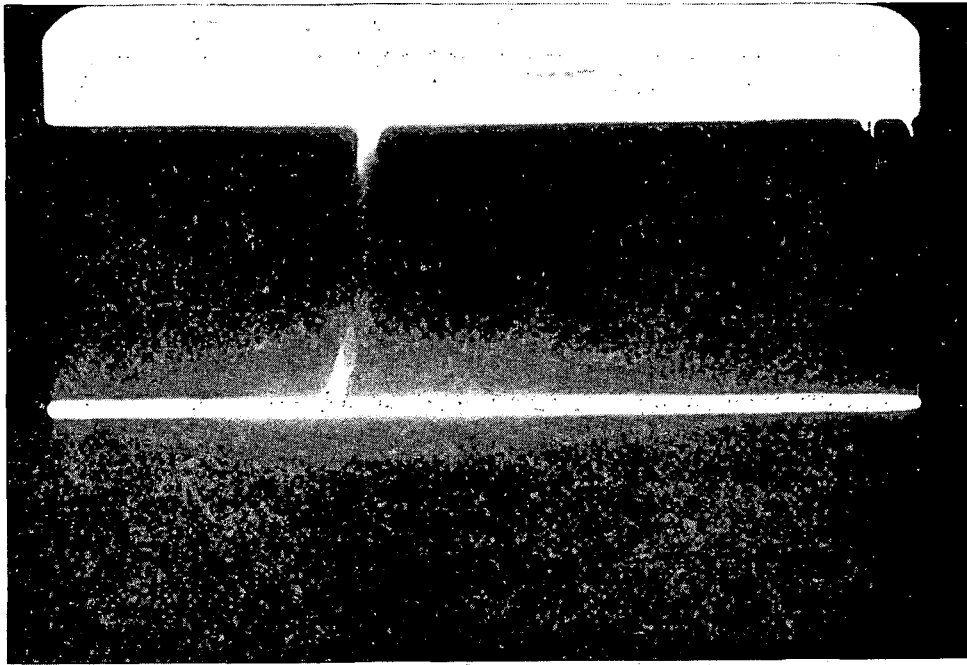
Fig.4

briquette, which was proofed by rolling the rod along its axis over 90° and making a further radiograph (Fig.4). Continuing the scan, a second crack much of the same size could be found 15 cm after the first one (Fig.5). After this no further crack or similar defect could be found (Fig.6 - Fig.9). Schematically the positions of the cracks are shown in Fig.10. In order to find the missing material, the area around the upper graphite briquette was radiographed (Fig.7). Because graphite has a much lower neutron cross-section than the U-ZrH alloy, the exposure time was reduced to 1.5 minutes, producing a better contrast on the radiographs (Fig.8, Fig.9). No significant sign of the presence of the fuel material dropped off the fuel briquette could be found. Therefore, it is estimated that either the material dropped off is too small to be detected, or that it is hidden elsewhere in the fuel rod and hence is not visible using the present method. Similar investigations were made with the second fuel rod (No. 7308) in combination with the same undefective rod (No. 7309), just having been used before. Three cracks have been found, the second and the third one, much of the same size as those in the other defect fuel rod. Only the first crack seems to be smaller than the others. The positions of the cracks in rod No. 7308 are shown in Fig.17; the radiographs in Fig.11 - Fig.16. In this specific case too the loose material could not be detected anywhere else.
