Final Report

TEMPLE OF HADRIAN Conservation Project 2012 – 2014

Conservation Project 2012 - 2014

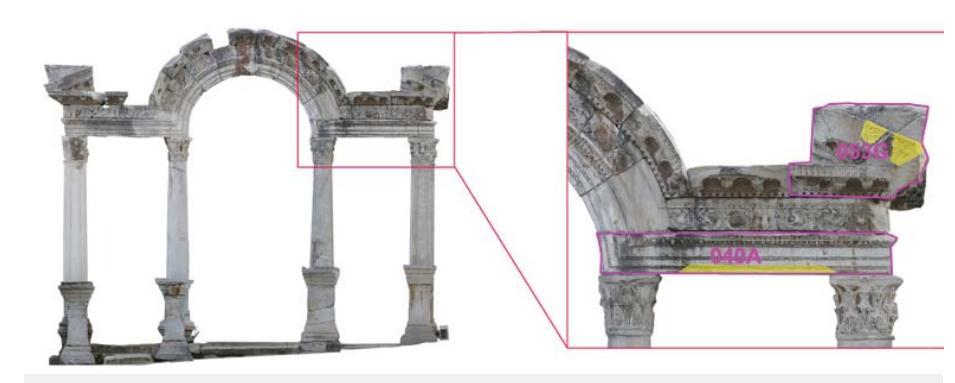
Localisation of stone fragments in danger of collapsing at the facade

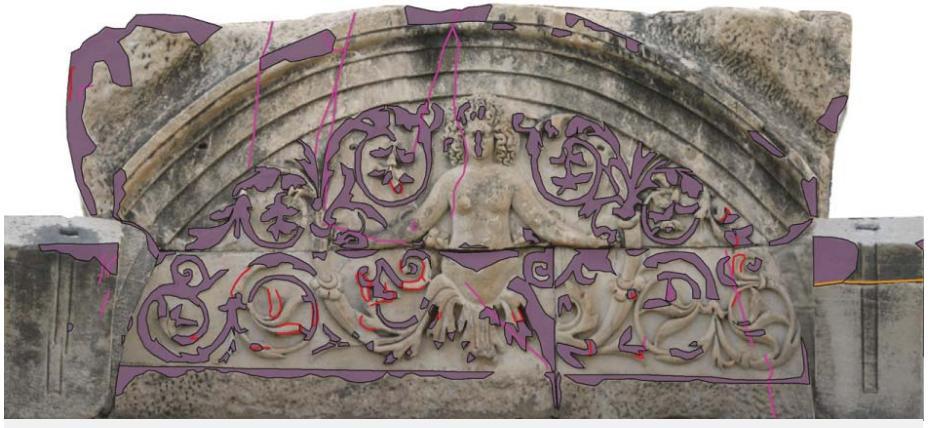
Documentation of cracks and losses at the tympanon

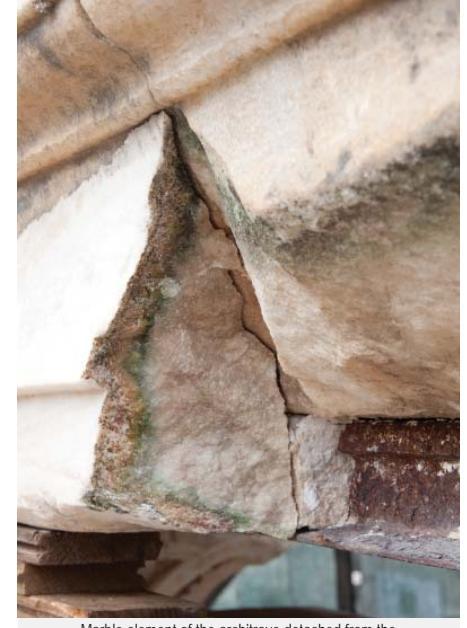
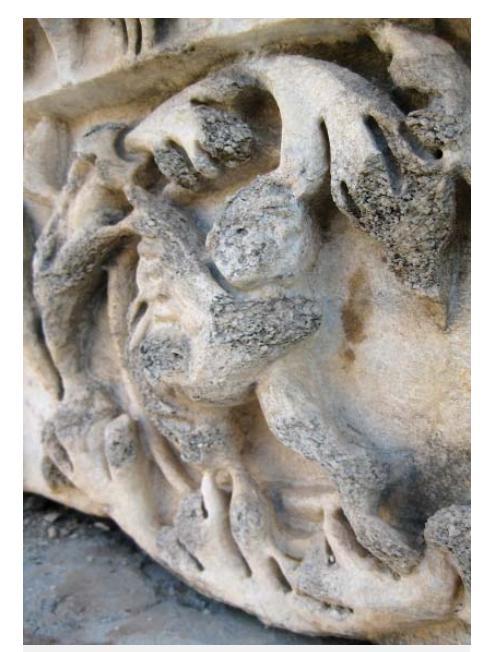
A common damage of the Temple of Hadrian was the corrosion of the iron elements that were inserted as pins and reinforcements of the marble blocks and as reinforced concrete in the 1950's. Individual iron elements had almost completely disintegrated and jeopardized the stability of the temple.

The corrosion process also placed pressure on the adjoining marble or concrete. This resulted in tension cracks and the risk of falling parts. Additional damage was caused by the deterioration of the marble surface into sugar-like crystals. This common process of weathering is the result of fluctuating temperatures and enhanced by additional factors, such as the dissolution or growth of microorganism. The structure of the crystals dissolves, individual kernels break loose and the original surface is lost.

Marble element of the architrave detached from the subsurface through the corrosion of the iron element

Sugar-like decay on the frieze

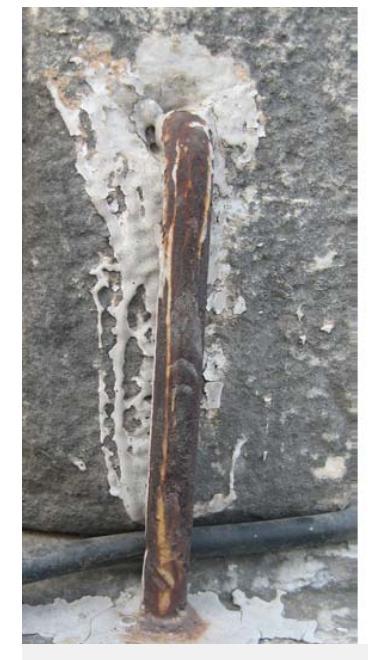
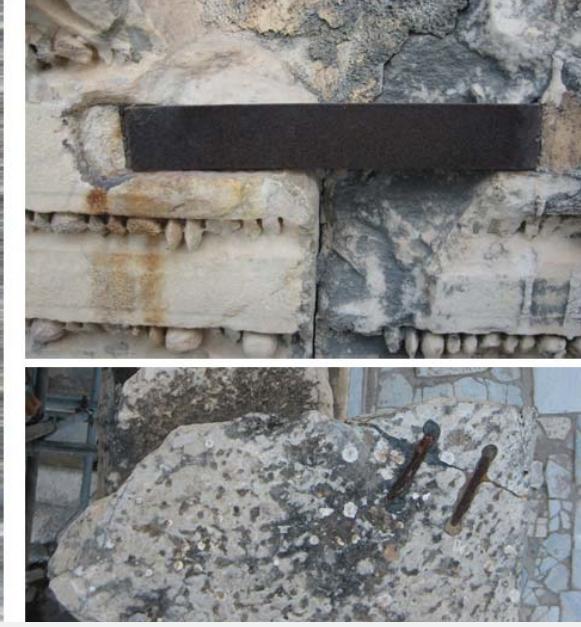
Problematic iron joints

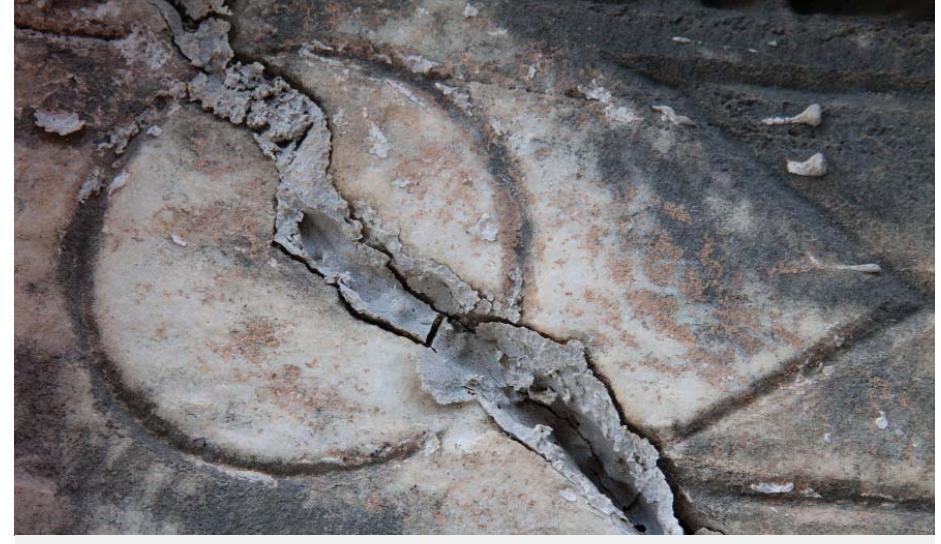
Damaged adhesion of polyester resins

The number of polyester resin adhesions was also alarming. The material was frequently used for the restoration of stone in the 1950's but was shown to not be age-resistant outdoors.

The resin shows clear tears and detached from the subsurface. It no longer acted as a bonding agent.

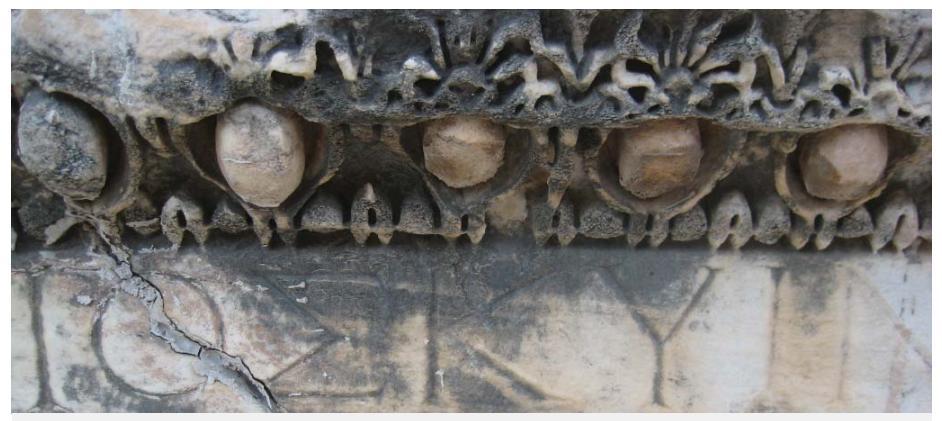
Damaged adhesion of polyester resins

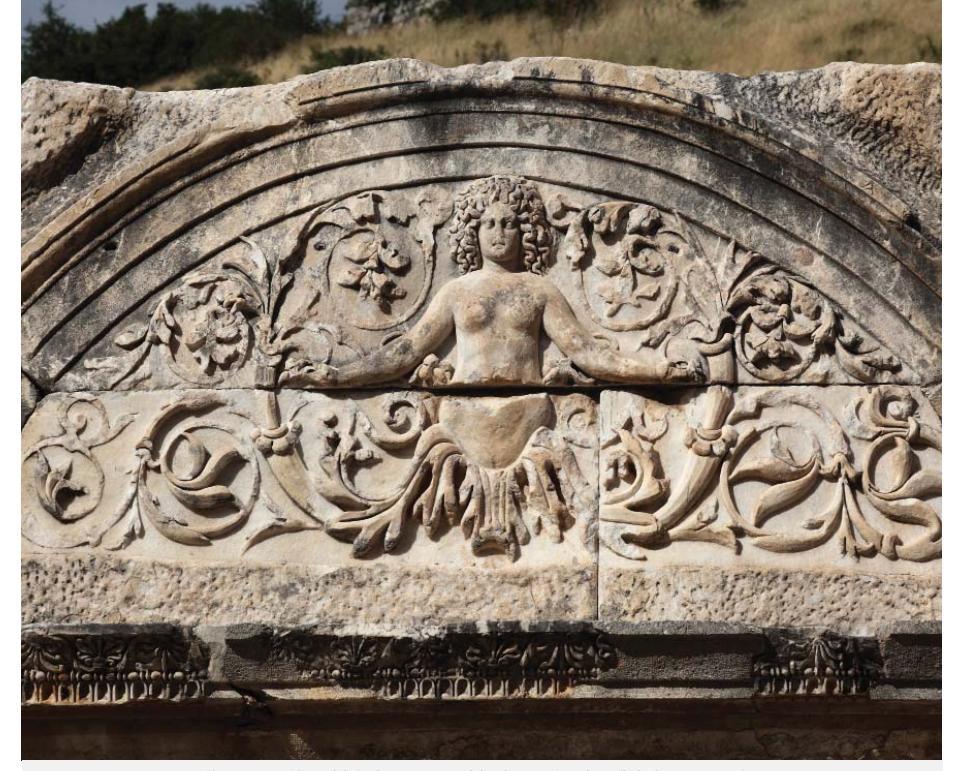
The woman with tendrils in the tympanon of the doorway into the cella before conservation
