5.4 DETECTION OF CRACKS IN TRIGA FUEL RODS BY NEUTRON RADIOGRAPHY, W. A. Pochman, A. Zeilinger, H. Böck, (Atominstitut, Vienna, Austria)

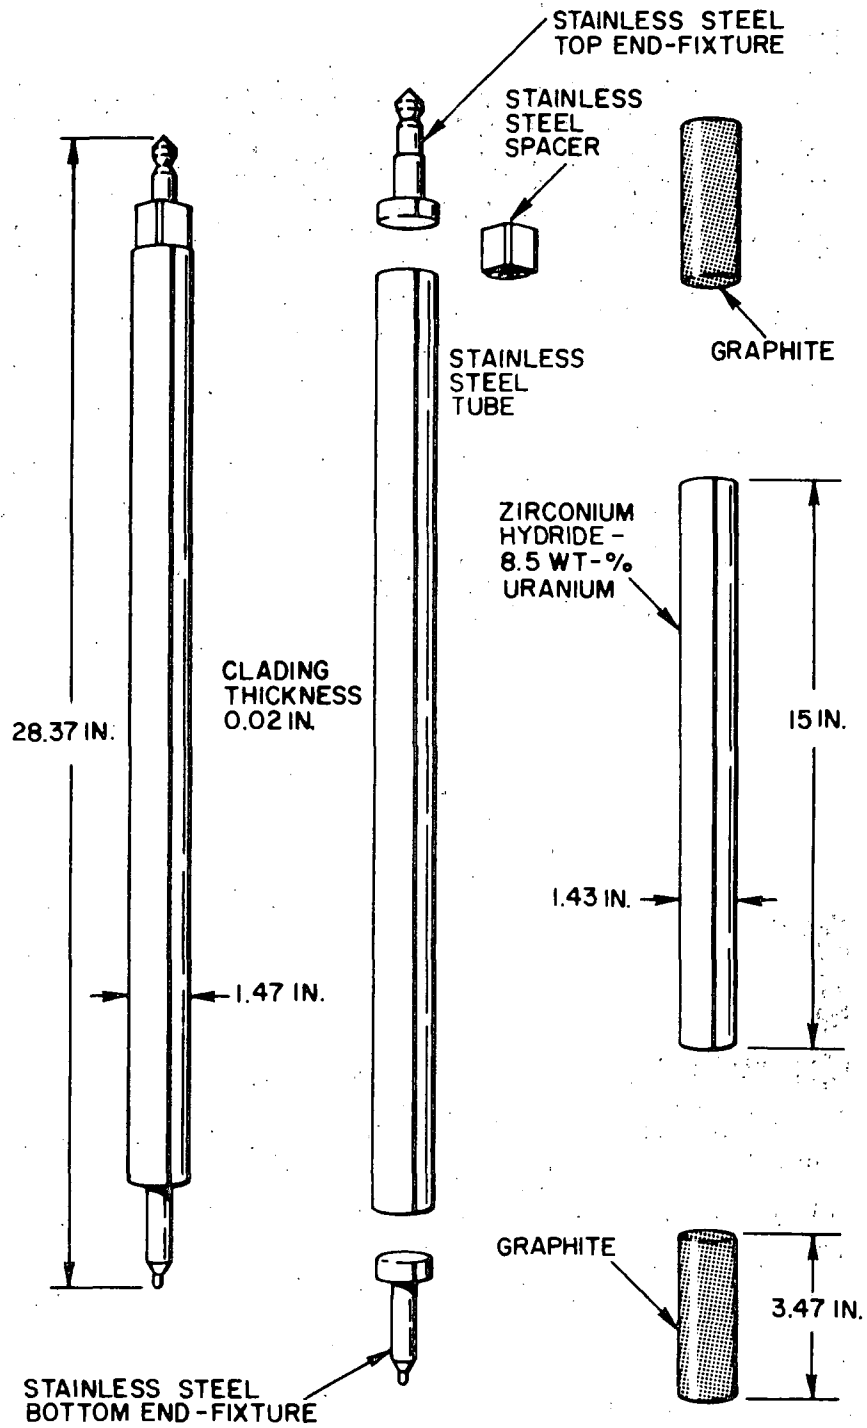
Fig. 1

The scan was started at the lower ends of the rods, respecting the 10 cm long graphite briquette, which was not radiographed, and having the rods held in such a position before radiographing, that any loose material must have assembled in the area round the opposite graphite briquette. A general assembly of a TRIGA fuel rod is shown in Fig.1.
